SCREENING SITE INSPECTION REPORT
FOR
BELVIDERE MUNICIPAL LANDFILL #2
BELVIDERE, ILLINOIS
U.S. EPA ID: ILD000605113
SS ID: NONE
TDD: F05-8902-021
PAN: FIL0584SA

MARCH 22, 1990

ecology and environment, inc.

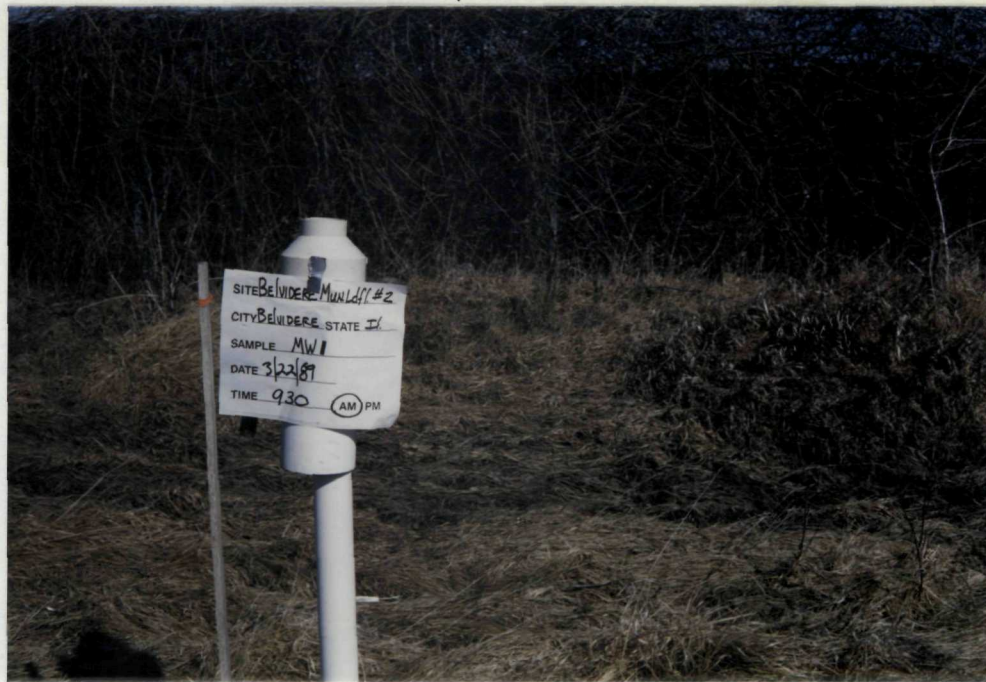
MW1

DESCRIPTION: close up photograph of MW1.

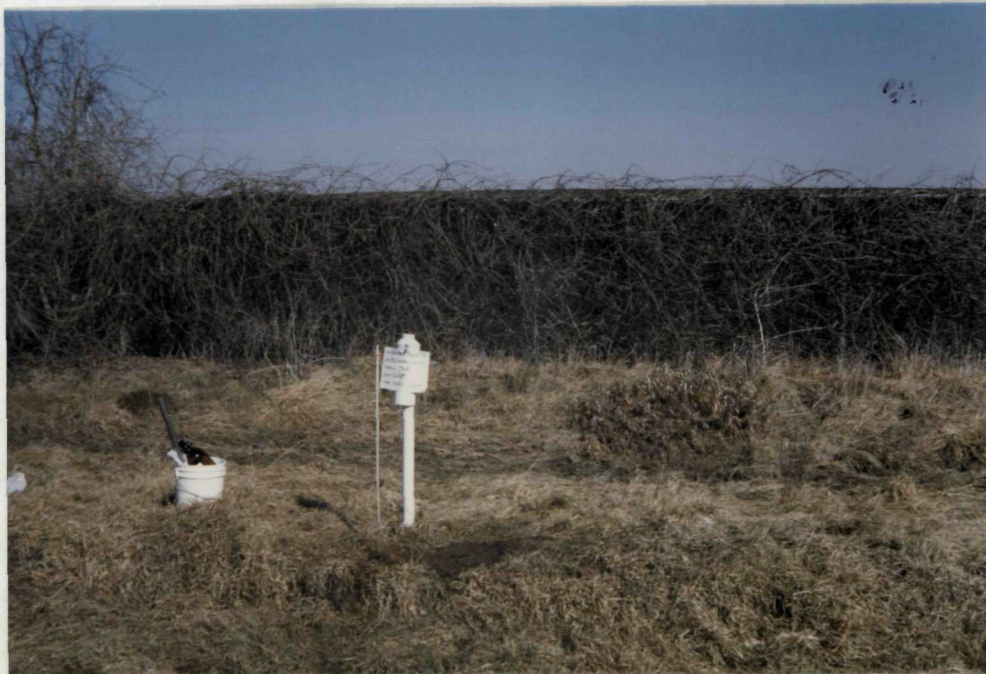
DESCRIPTION: Perspective photograph of MW1

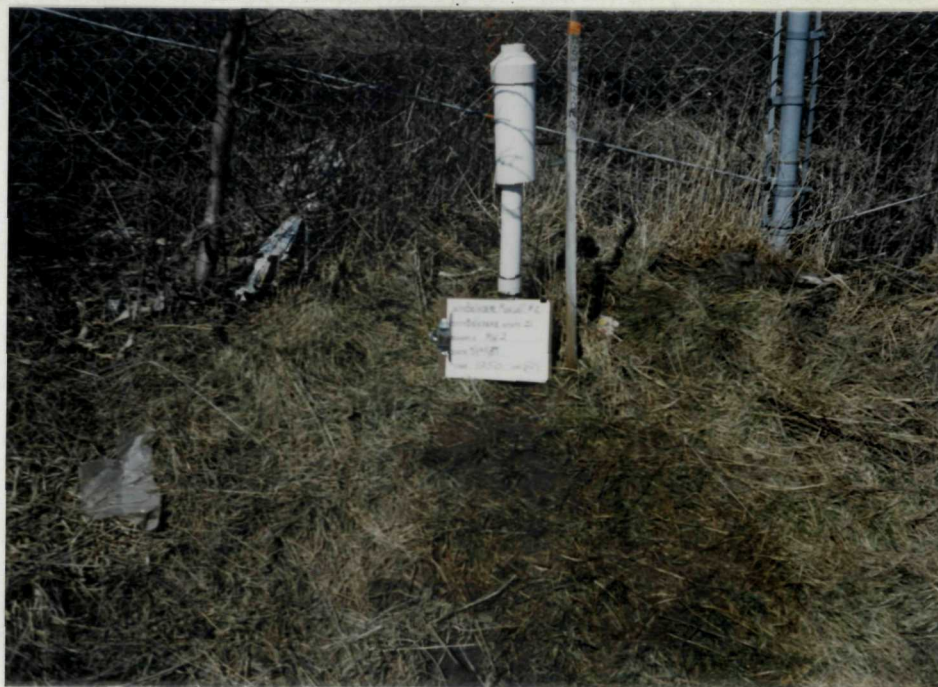
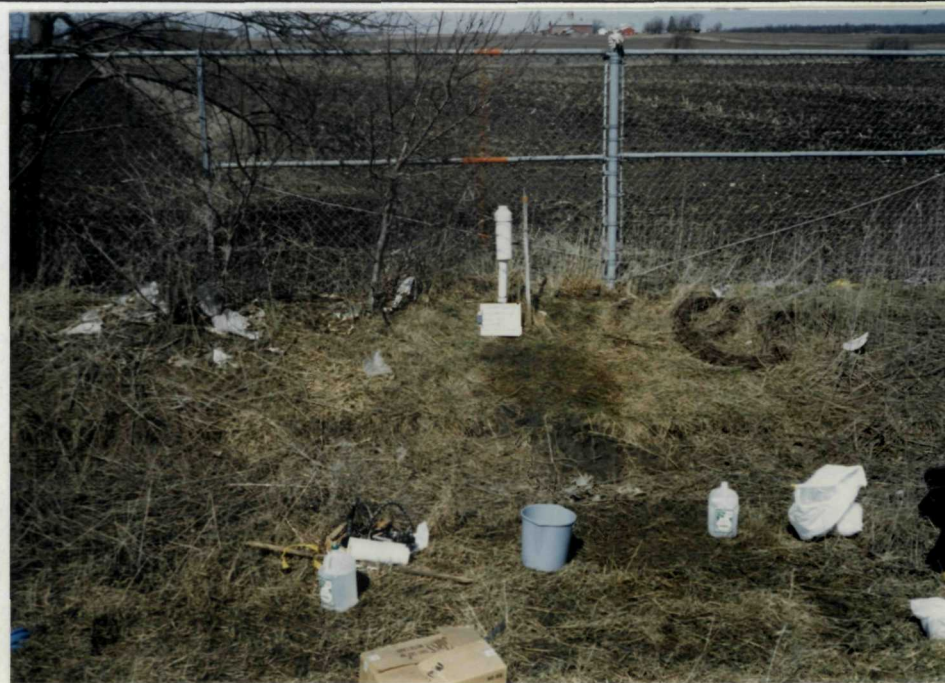
While venting MW2, FIT detected elevated readings of methane with the OVA 128. FIT also observed that MW3 did not have a cap fitting onto the polyvinyl chloride (PVC) casing of the well and that the cover over the well was not locked. FIT noticed an odor at MW3 upon venting the well, although no readings were detected with the OVA 128.

DESCRIPTION: Close up photograph of MW2.DATE: 3-21-89TIME: 1250DIRECTION OF
PHOTOGRAPH:NWEATHER
CONDITIONS:30°Fclear, Sunny

DESCRIPTION: Perspective photograph of MW2.

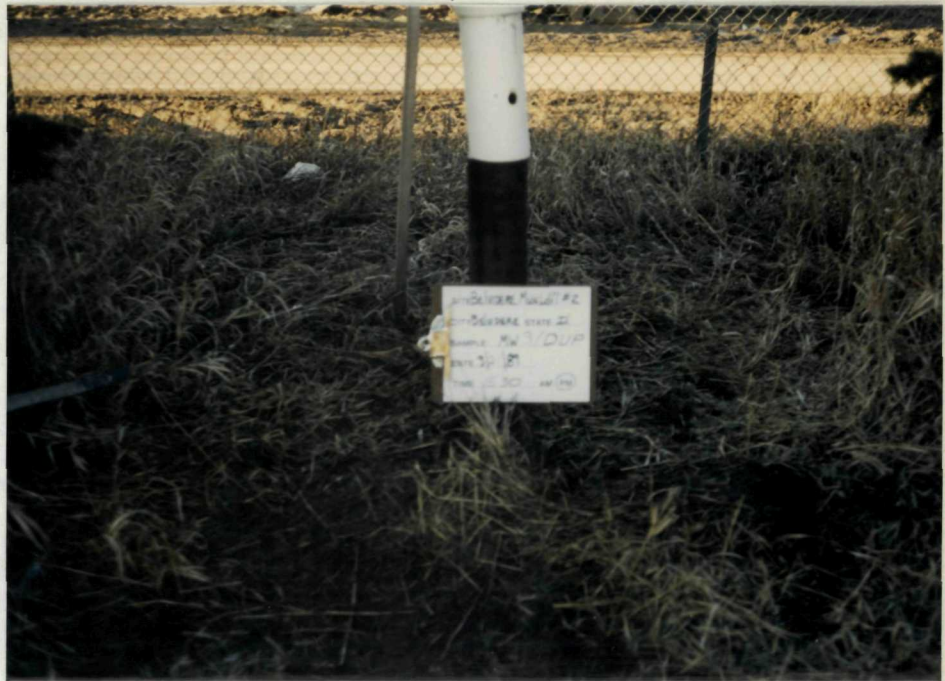
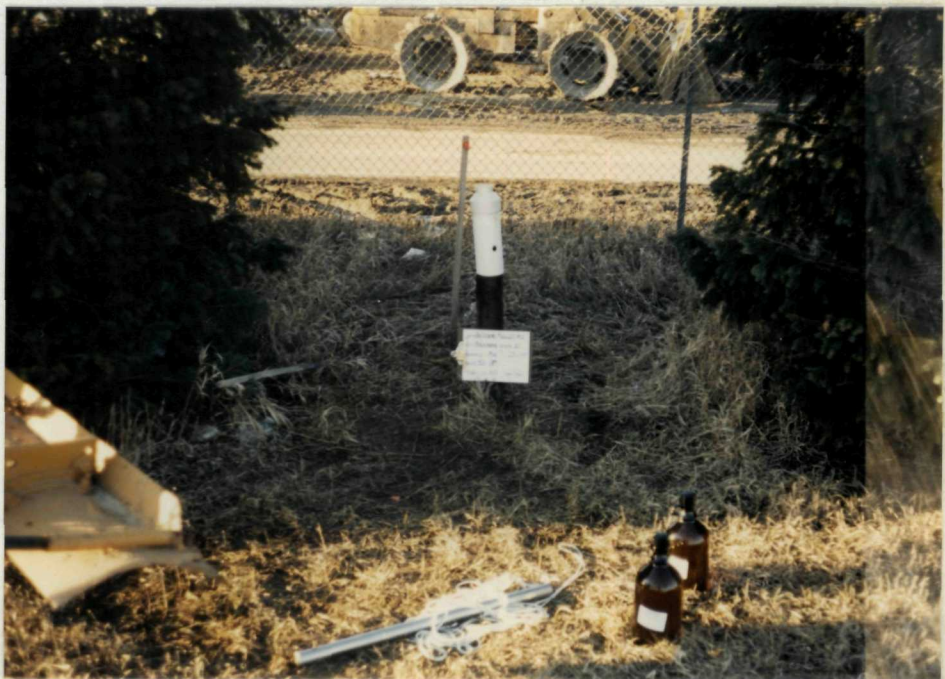
DESCRIPTION: Close up photograph of MW3.

DESCRIPTION: Perspective photograph of MW3. Photograph taken after completion of sampling.
